A release of nitrogen oxides in Bogalusa, Louisiana and similarities of causation to the Bhopal MIC release[☆]

V.M. Fthenakis *

Abstract

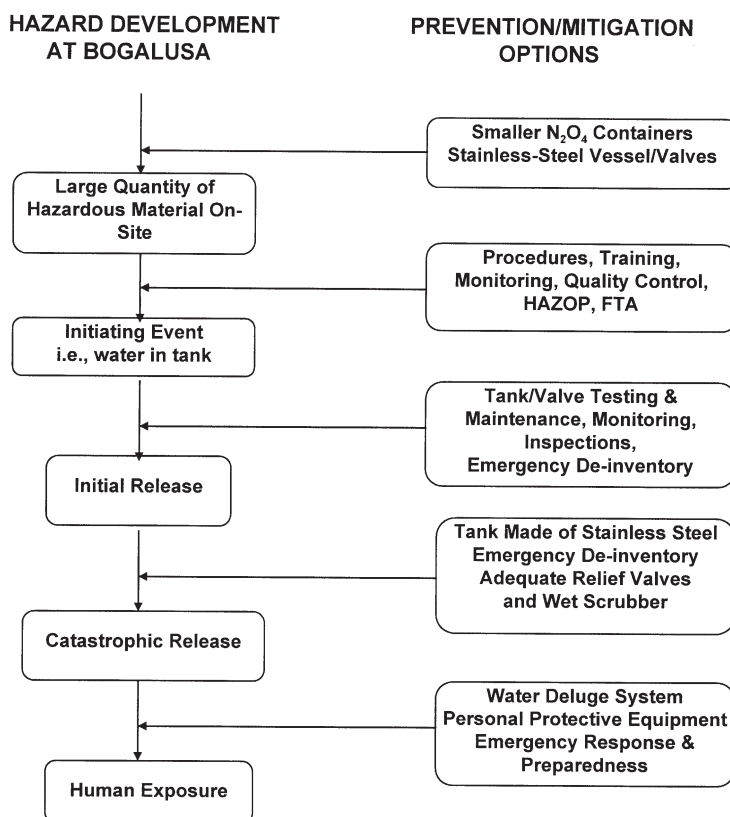
Louisiana facility. These are shown in Fig. 1, and outlined below:

1. Inherently safer processes, materials, and procedures.
2. Options to prevent accidental initiating events.
3. Safety systems to prevent or minimize releases.
4. Options for control/mitigation.
5. Emergency preparedness and response plans, and procedures to prevent or reduce human exposures.

Fig. 1. Hazard development at Bogalusa and options for prevention and mitigation.
